Technical Info

No. 02 / 22-01-07

RCXX and RFCXX Compasses

Loose wires in plug-in terminal board

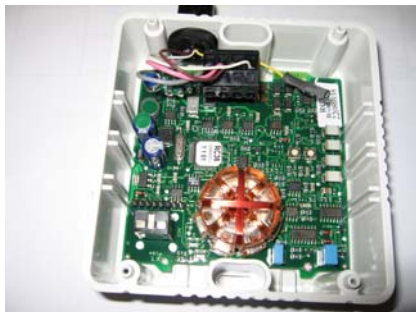
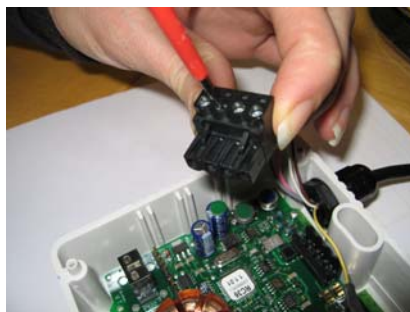
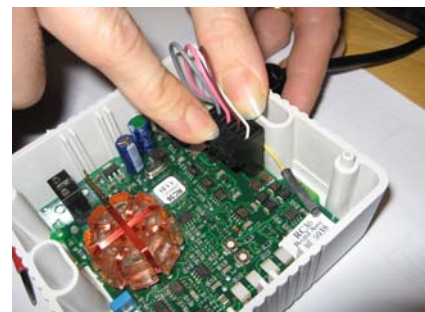
Further investigations have revealed that one or more wires in the compass cable may come loose in the plug-in terminal at the pcb because the terminal screws have not been fully tightened.

See attached photos showing the terminal inside a RC36.

The compasses need to be opened and checked for loose wires.

If you receive any reports of intermittent compass problems could you please ensure that the wiring to the plug in terminal is checked and if necessary secured.
